**DIN L-ART HELWA**  
**PRIZE FOR ARCHITECTURAL HERITAGE 2018**

**RESTORATION AND CONSERVATION CATEGORY**

**INSTALLATION OF AN ENVIRONMENTAL CONTROL SYSTEM FOR THE  
CONSERVATION OF THE GRAND MASTERS' CRYPT AT  
ST. JOHN'S CO-CATHEDRAL, VALLETTA**

**TBA periti**

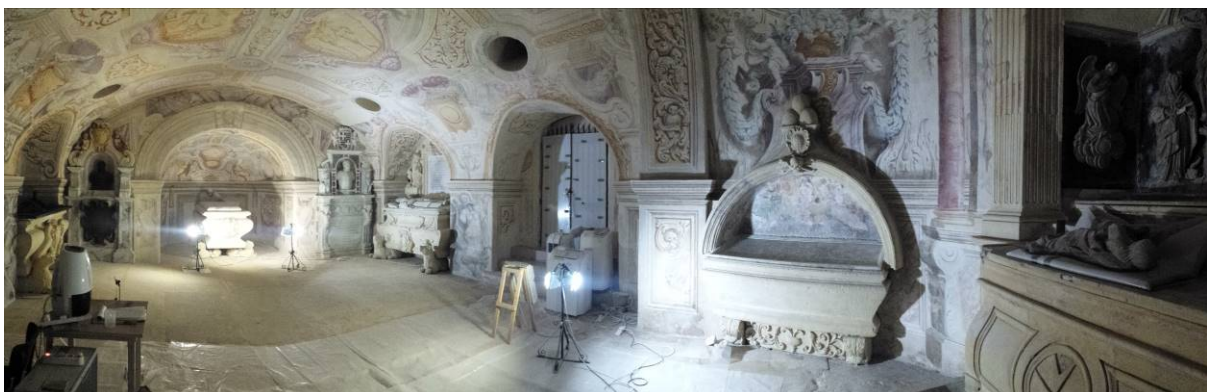
Figure 4: General image of the Crypt depicting the temporary/portable equipment located adjacent to the (only) entrance.

Prior to this project, the ambient temperature and relative humidity within the Crypt were controlled with three standalone A/C units, a humidifier and a de-humidifier, all of which were controlled manually, and all of which could not be properly positioned within the Crypt because of the site restrictions within the Crypt itself. The temporary equipment did not respond efficiently to sudden weather fluctuations, and therefore, some damage/deterioration was unavoidable. This setup was closely monitored by the in-house conservator, who constantly manually-adjusted the equipment, so as to try to improve the ambient conditions of the Crypt.

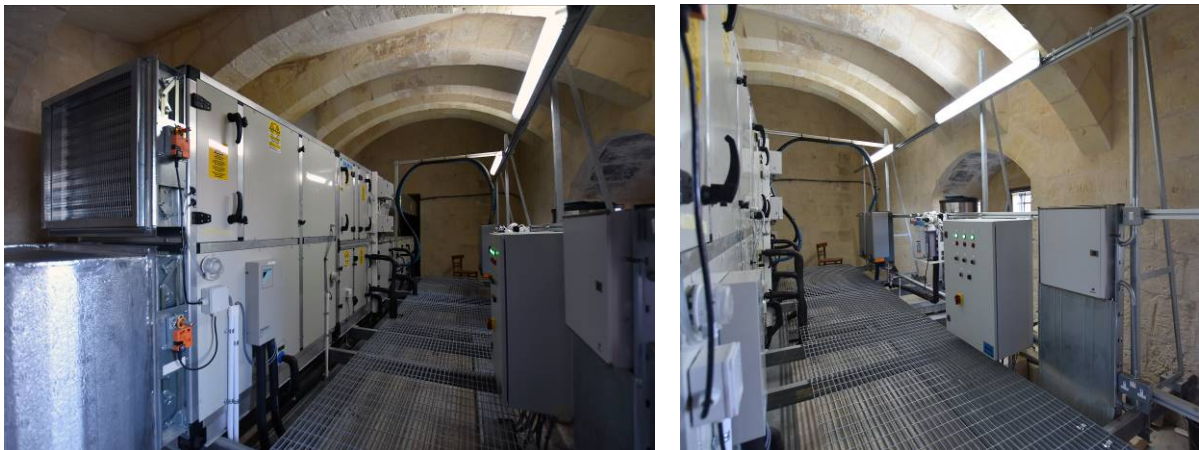
Figures 6a and 6b: The 'North Prison' fully equipped with the plant and equipment which is completely independent of the existing masonry fabric

The equipment is supported on an independent and completely reversible steel structure composed of galvanised telescopic beams, which are supported on the existing load bearing masonry walls of the North Prison. The ends of the telescopic beams are supported within the thickness of the existing mortar joints, thus avoiding any irreversible interventions to the masonry fabric. In addition, between the telescopic beams and the equipment, there are a series of isolators acting as 'shock absorbers', which eliminate any vibration

transmittance from the equipment into the masonry fabric. In this way, the existing limestone slab flooring ('*cangatura*') and existing roof are not affected in any way.

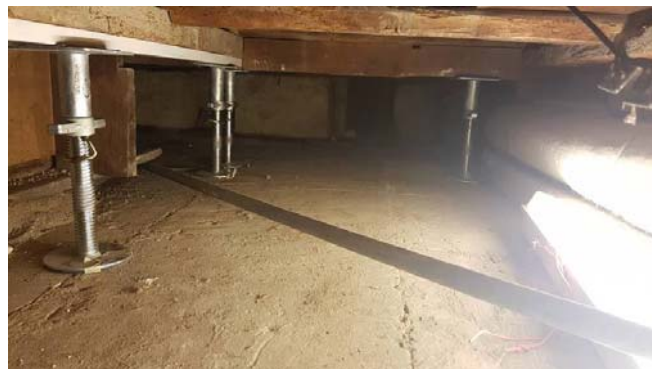
Figure 7: New structural steelwork elements beneath the choir stalls to free up the space required for the ducting

At Main altar level, the ducts emerged within an existing cabinet adjacent to the Main Altar (separated by a wall). Thus following numerous site meetings with the Superintendence of Cultural Heritage, the location for a small breach in the masonry fabric was identified. Through this breach (roughly 600mm by 300mm) the ducts emerged directly beneath the existing choir stalls, which are raised by about 500mm above the Main Altar finished level. The space beneath the choir stalls which was easily accessible was just about large enough to accommodate the required ducts. The choir stalls floor is composed of a number of timber boards, these were temporarily removed and eventually reinstated. The supporting structure beneath the choir stalls, which included considerable interventions, was composed of vertical timber elements (which were retained) and large masonry units, placed to provide additional support to the deteriorated horizontal timber elements. These large masonry units were carefully replaced with neat (slimmer) galvanised steel supports, which freed up the space required to accommodate the ducts.

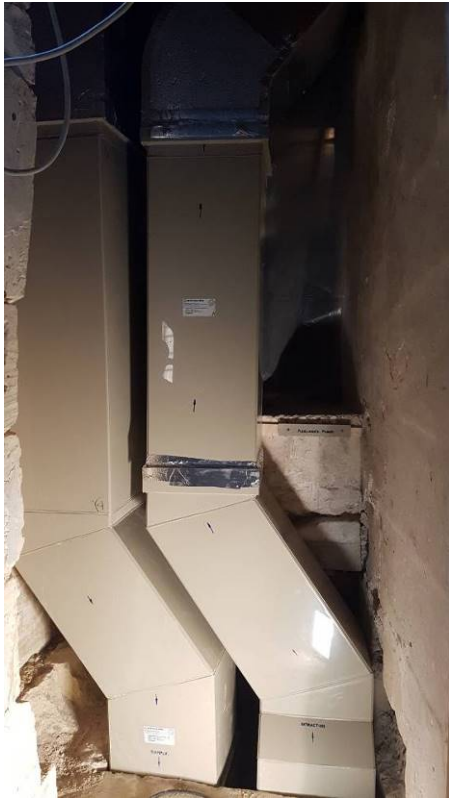
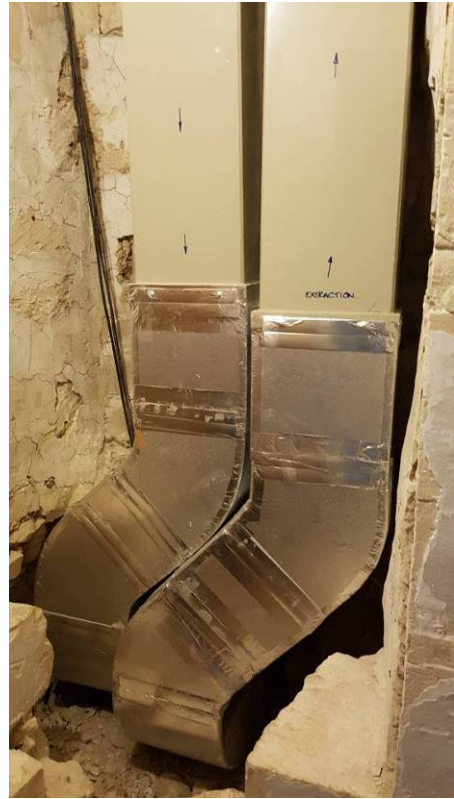
Figures 8a and 8b: Ventilation ducts tucked away neatly within the existing restricted spaces

The North Prison links up to a small room, which is located above the secondary spaces described above. These small rooms/spaces, on three overlying levels, go down to altar level. The ventilation ducts, therefore, branch off into this small space, and through two minor interventions within the masonry fabric, and by utilising the existing openings (created to accommodate the organ equipment), and previous interventions and recesses within the wall thickness, they arrive within a cabinet (recessed within the wall thickness) at Main Altar level. Where the masonry was intervened upon, all the masonry units/elements were duly numbered and retained for possible future re-instatement. During the course of the works, a number of very interesting 'lost/covered' features were re-discovered, thus shedding light on the timeline of the Co-Cathedral. These features will be very briefly described in Section 4 of this presentation.

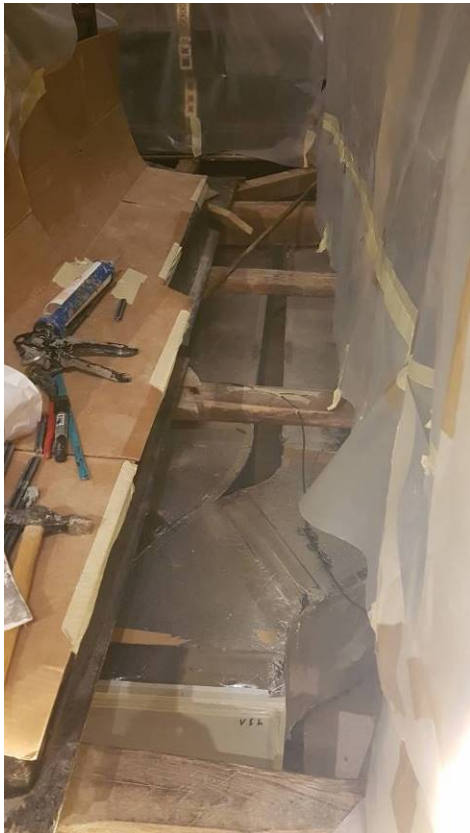
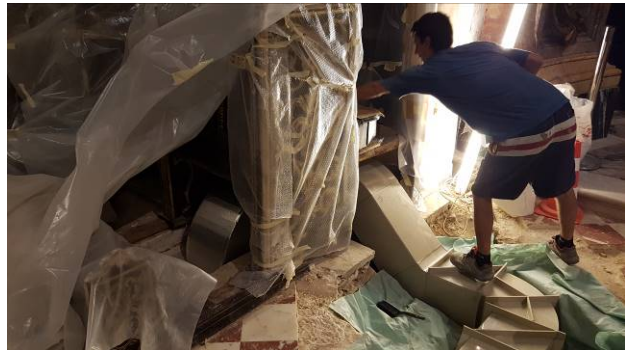
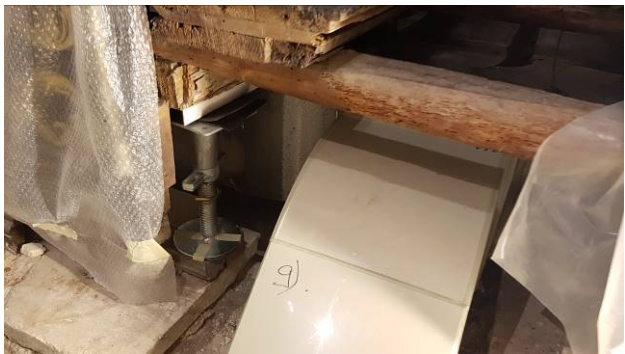
Figures 9a, 9b and 9c: Ducting very neatly accommodated beneath the choir stalls, and the custom-made ducts produced to travel beneath the Main Altar.

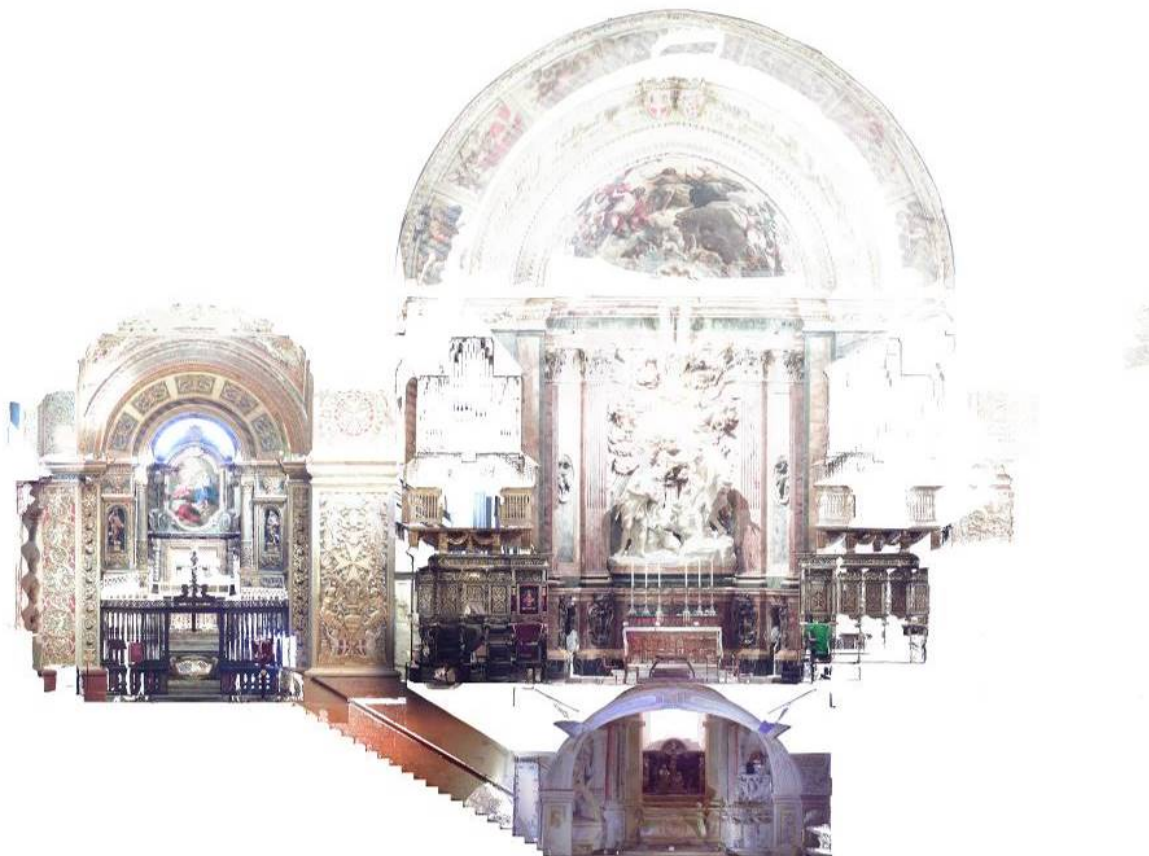
Figure 10: Detailed sections through the Crypt produced using a 3D scan, showing the oculi and the Main Altar

Numerous sections were drawn up at various locations, so that the depth of the build-up and underlying structure could be accurately identified. From these sections running through the oculi and highest vault position (within the Crypt), it became clear that the volume of fill and the building fabric varied between approximately 650mm and circa 1100mm. The space required for the ducts and overlying marble floor did not exceed 500mm.

As a result of this further investigation, the proposed route to cross the Main Altar (above the highest point of the Crypt), was altered from the approved route in PA 1955/15, in accordance with the Superintendence of Cultural Heritage. The route was amended so as to ensure an available depth of at least 1000mm. During the course of the works, crossing the Main Altar with the ducting became easier, since an older finish was discovered at a lower level, which was low enough for us to accommodate the required ducts and reinstate the *cangatura* and overlying marble tiles.

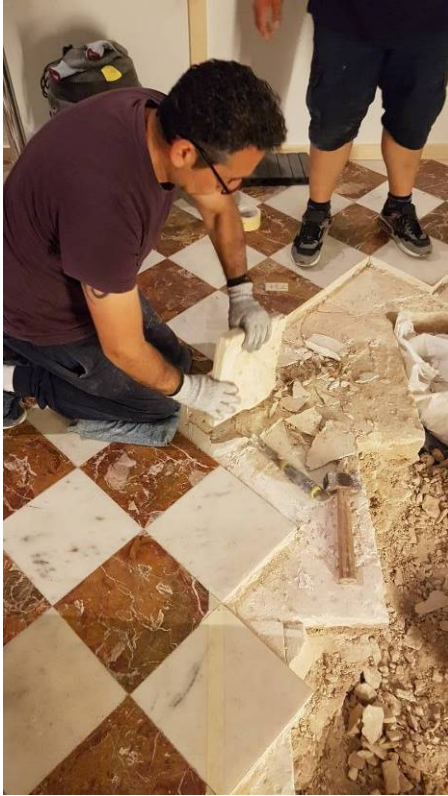
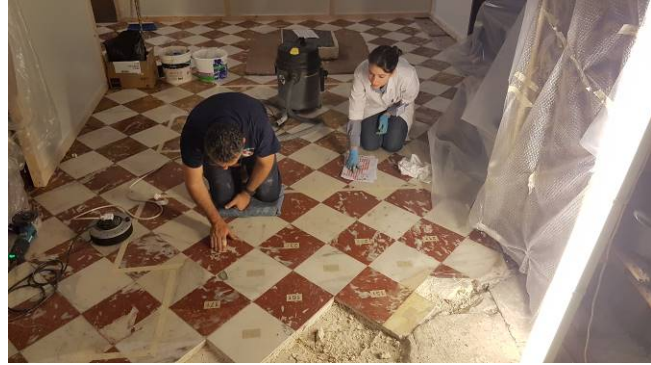
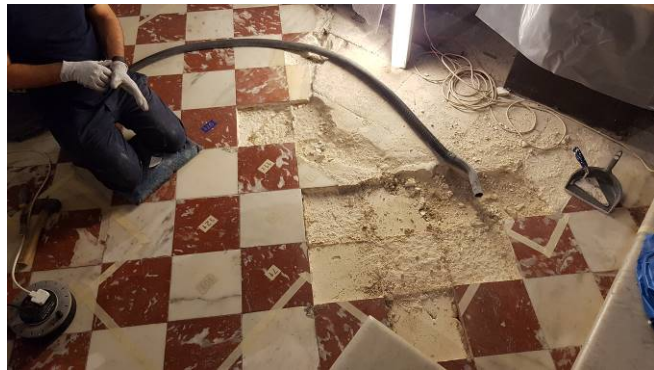
Figures 13a, 13b and 13c: Marble tiles duly marked and very carefully removed

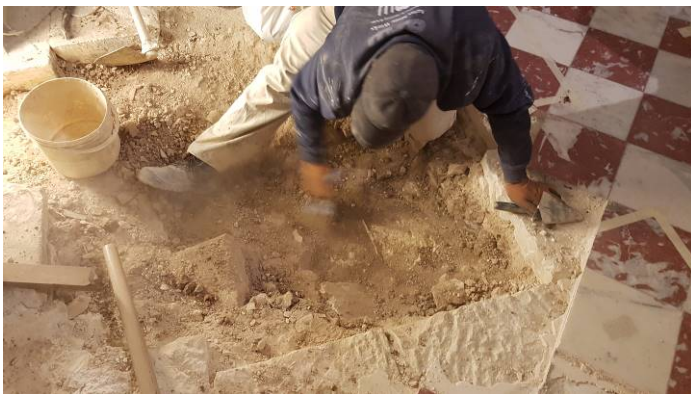
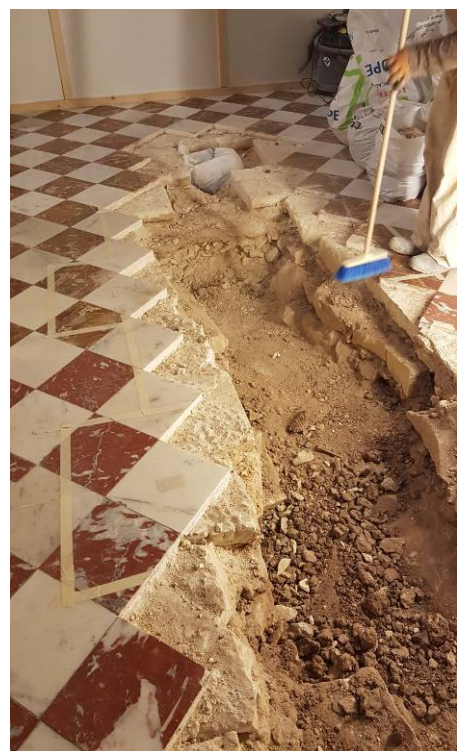
Figures 14a and 14b: Images showing the delicate removal of material to prepare the route for the required duct work. The route linked up all the four oculi.

Once the cangatura were removed, the underling material was uncovered. The material consisted of a mix of soil and random rubble. This was carefully removed using hand held chipping hammers and small hand tools. All the material was stored in sacks, for eventual reinstatement.

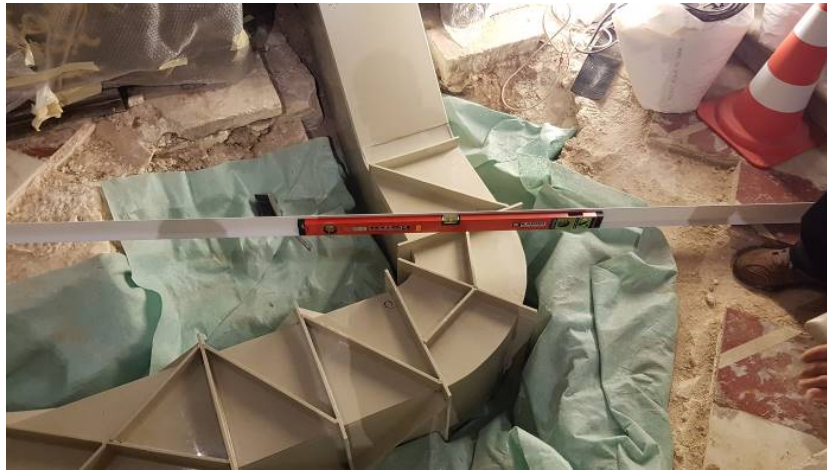
Figure 15: Detail of the custom made ducting within the routes created

Once a portion of the route was defined, the ducts were installed. The ducting used beneath the Main Altar were custom-made, and structurally-capable of withstanding the superimposed dead and live floor loading. The ducts were manufactured on site, to fit within the restricted spaces, using polypropylene material so as to avoid corrosion of the ducting. Each length and section was made to measure.

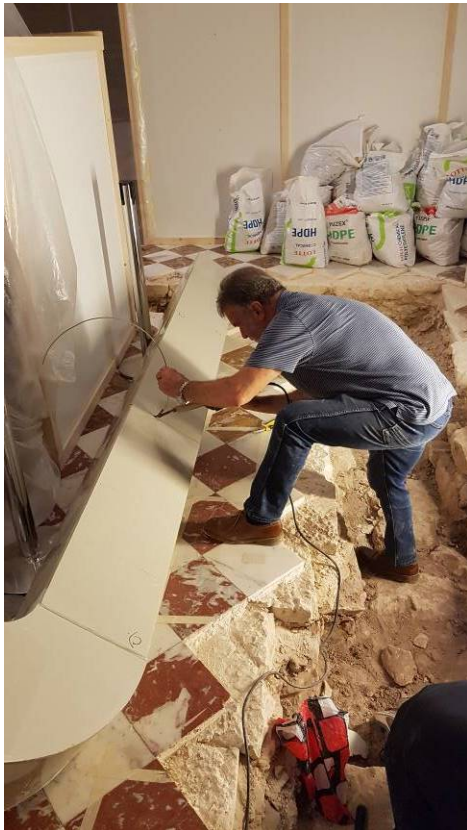
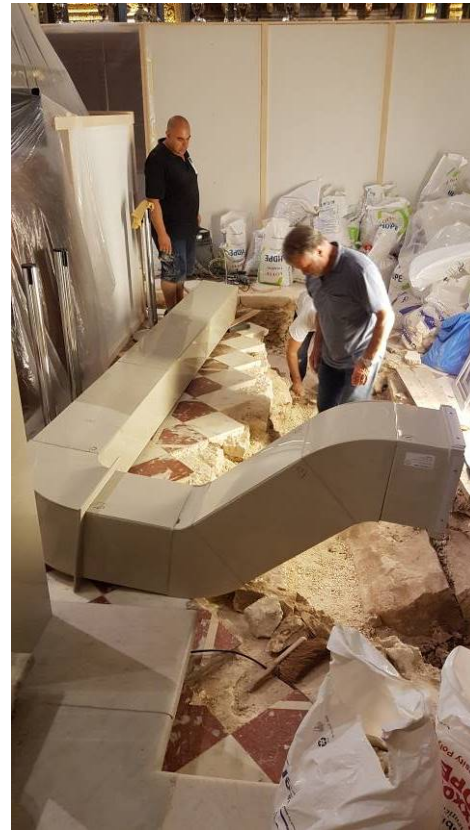
Figures 16a & 16b: Custom made ducts being manufactured on site to fit within the restricted & awkward spaces.

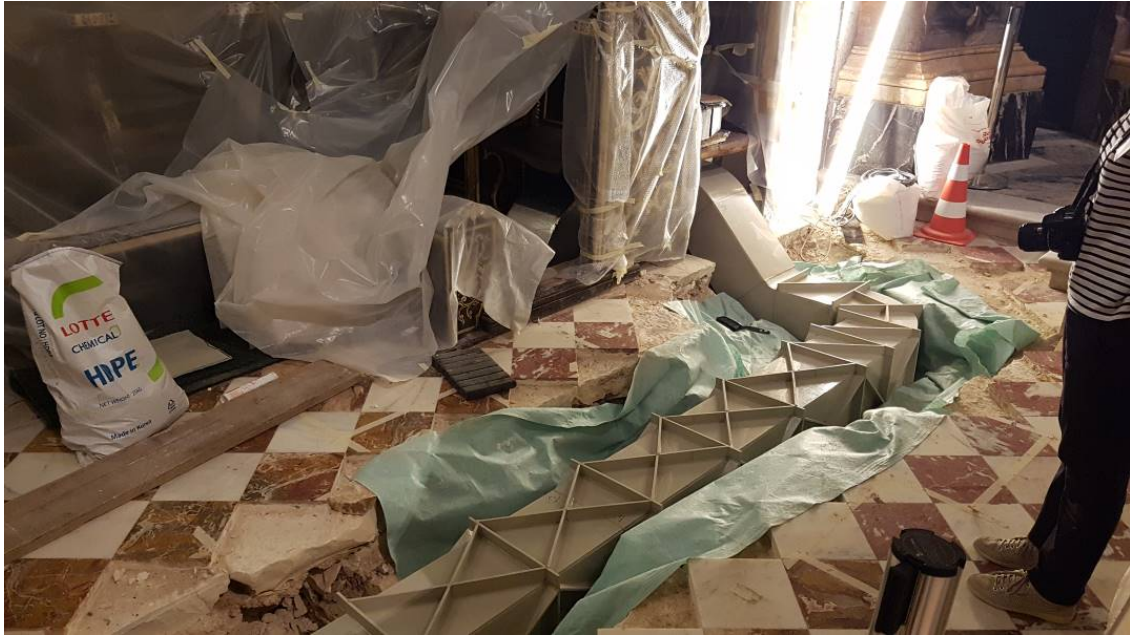
Figure 17: Reinforced and strengthened duct inserted within the space available with underlying geotextile.

Once the duct runs were complete, the space between the duct and the unearthed material was carefully backfilled using the same material removed. This material, when re-instated, was mixed with hydraulic lime and very small quantities of water to ensure that the spaces are properly backfilled and compact. The 'new' re-instated material was isolated from the 'original' undisturbed material with the introduction of a geotextile, thus clearly identifying the areas intervened upon. The masonry *čangatura* removed, which could not be completely re-instated (due to the limited depths available), were numbered and stored on site.

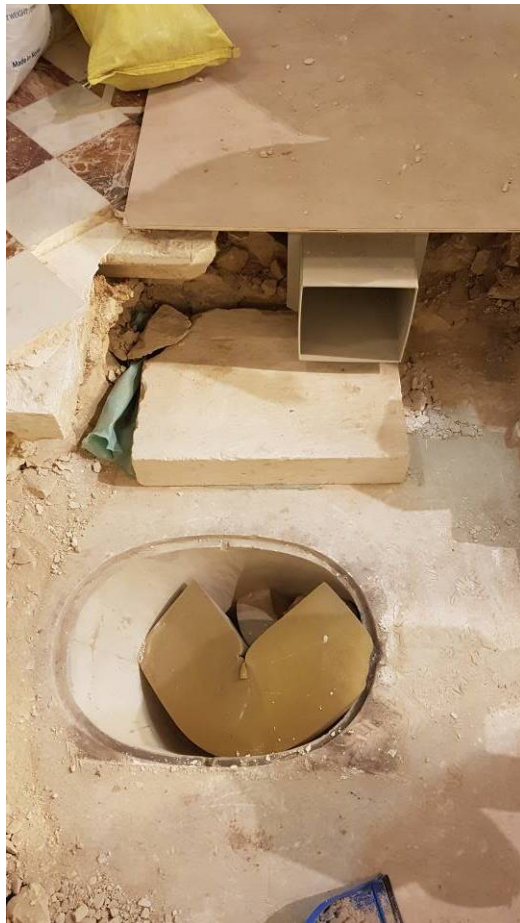
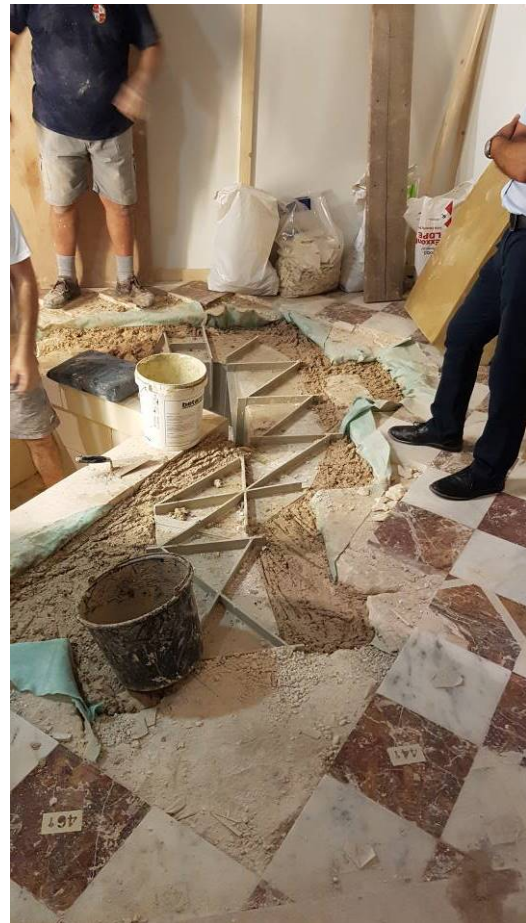
Figures 18a and 18b: The oculi exposed at Main Altar level, together with the 'original' *cangatura* and finished floor level. The carefully removed volume to accommodate the duct was then carefully backfilled

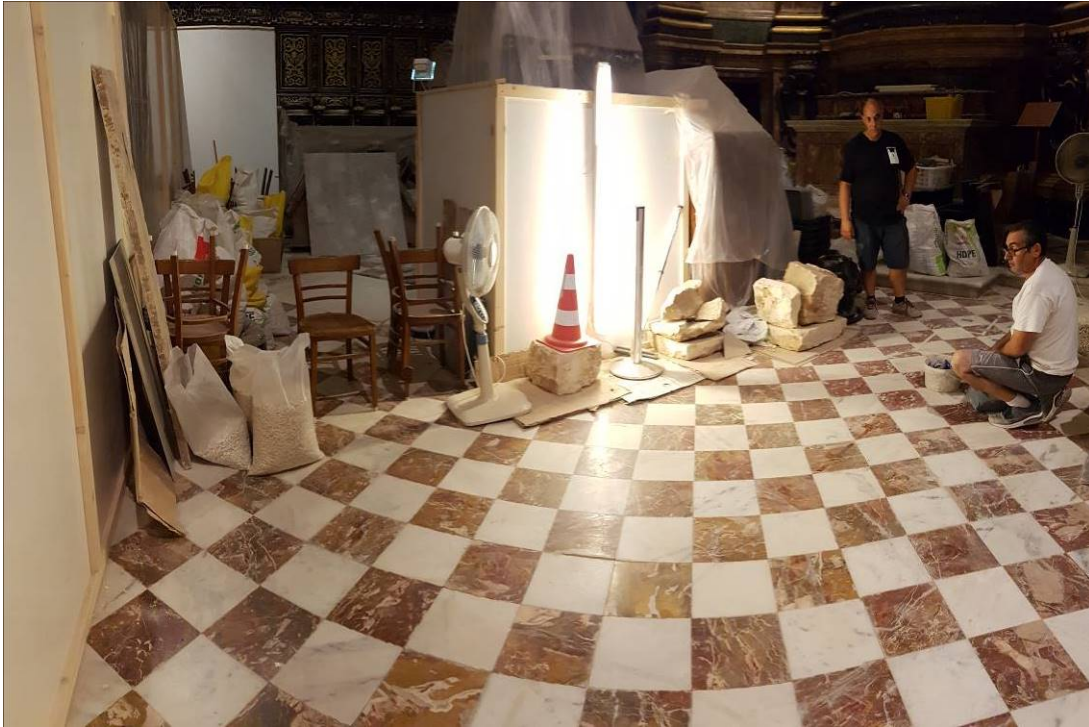
Figure 19: All the tiles were reinstated once the duct work was all installed and tested beneath the Main Altar

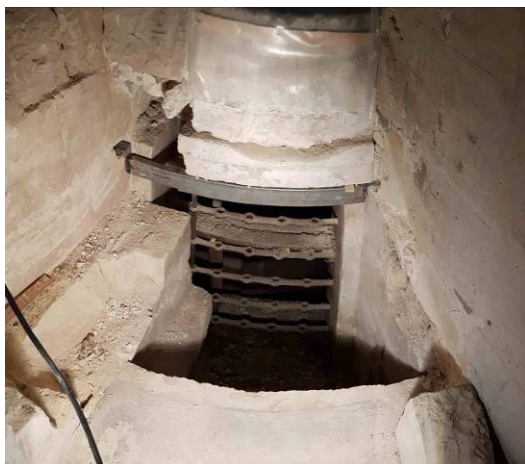
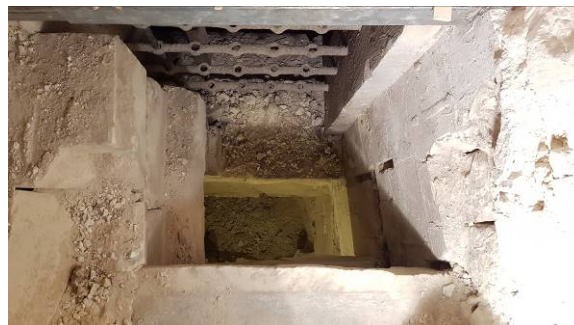
Figures 21a and 21b: Elements forming the 'original security bars, and windows jambs uncovered.

Above the cabinet where the ducts were accommodated an 'original' window was uncovered. This was blocked off to accommodate the entrance for the organ. *Could the 'original' extent of the Co-Cathedral been different?*

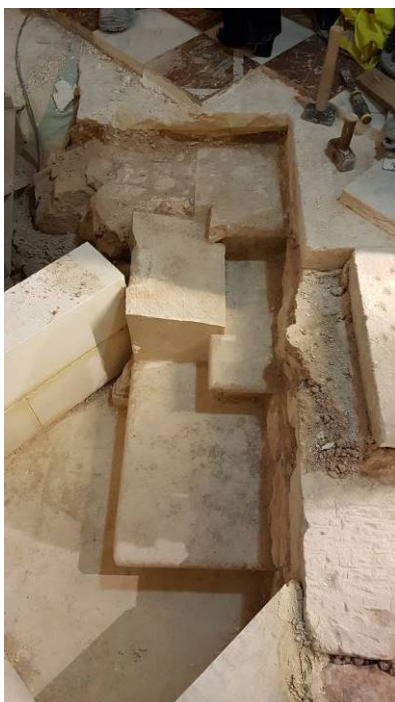
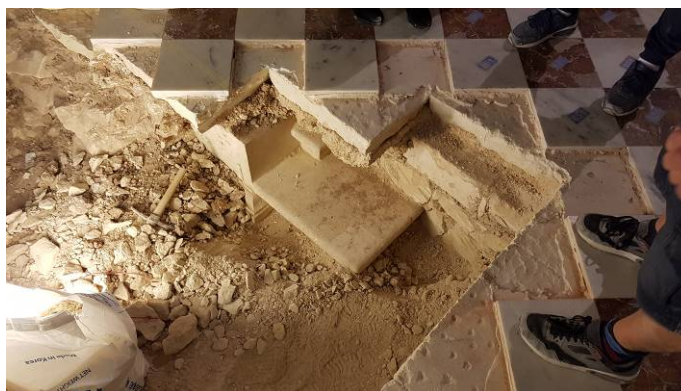
Figures 22a and 22b: Beautiful details (old steps and a lower 'original' floor finish) uncovered, thereby shedding light on the changes/ development of the Main Altar.

Upon further investigation, more of the *çangatura* finish was uncovered and eventually, towards the centre of the Main Altar, two steps were also uncovered, each having a rise of between, 160mm - 170mm, which suggests that four steps were required to reach the existing FFL set at +660mm for the uncovered older finished floor level;

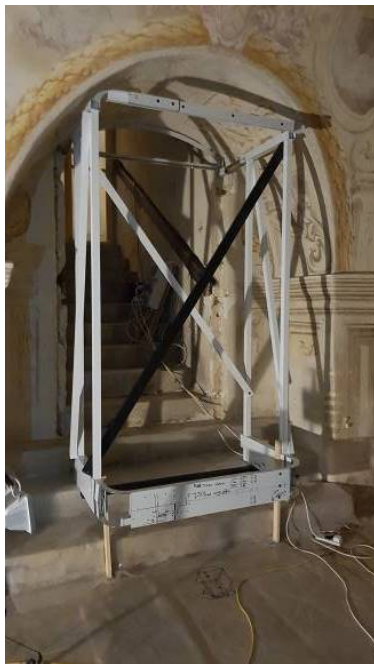
Figure 24: Image of a full scale model of the viewing gallery/platform, being fitted on site, to assess the contact points, thus ensuring that no damage is caused to the existing masonry fabric. The actual gallery/platform, which will include curved glass will be installed towards the beginning of 2019.

The Crypt is to have a viewing gallery/platform installed at its entrance to allow visitors the possibility to view this magnificent space, which has been closed off to the public for the past 25 years. The viewing gallery will be glazed and openable to allow access into the crypt for maintenance and restoration works.
